NON INVASIVE
BUILDING REPORT

123 Anywhere Street
Suburb
City

Following your instructions we visited the above property on the 11/06/12 to carry out a non-invasive building inspection of the dwelling at the above address: following is our report.

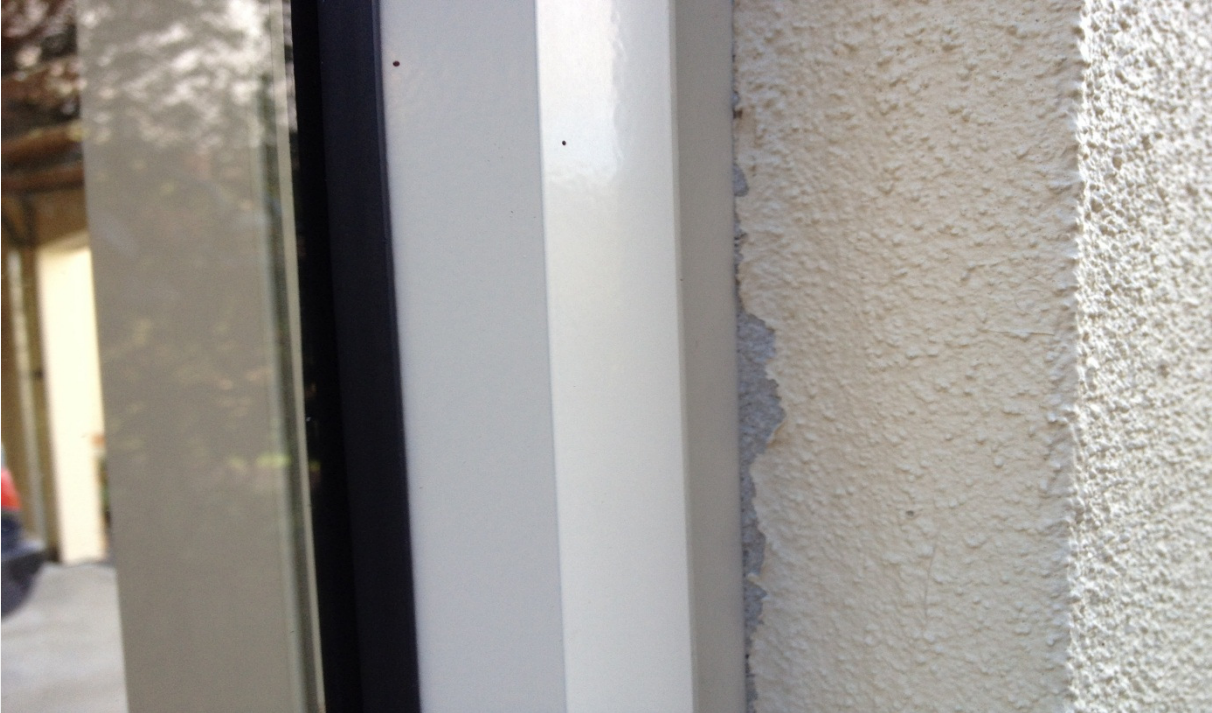
(1) *Paint has peeled away from the window surround on the S/W garage window this will require repainting as the plaster can be porous without paint protection.*

- 1) Prepare and Paint window surround on garage window where paint has peeled.**
- 2) Seal and paint crack in sill flashing below bedroom 2 window.**
- 3) Fit spouting back onto clips where sky aerial has been installed.**
- 4) Replace cracked mortar in ridge tiles**

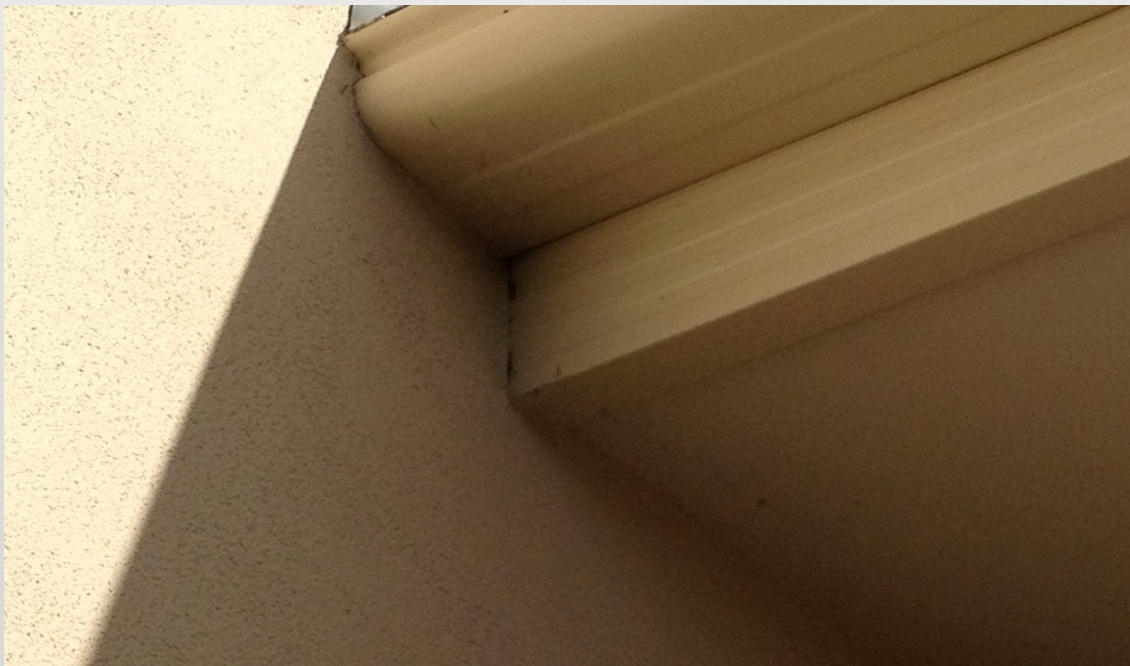
2)

(2) *There is a minor crack along the sill flashing below Bedroom 2 window on the western wall. This area will require sealing and repainting.*

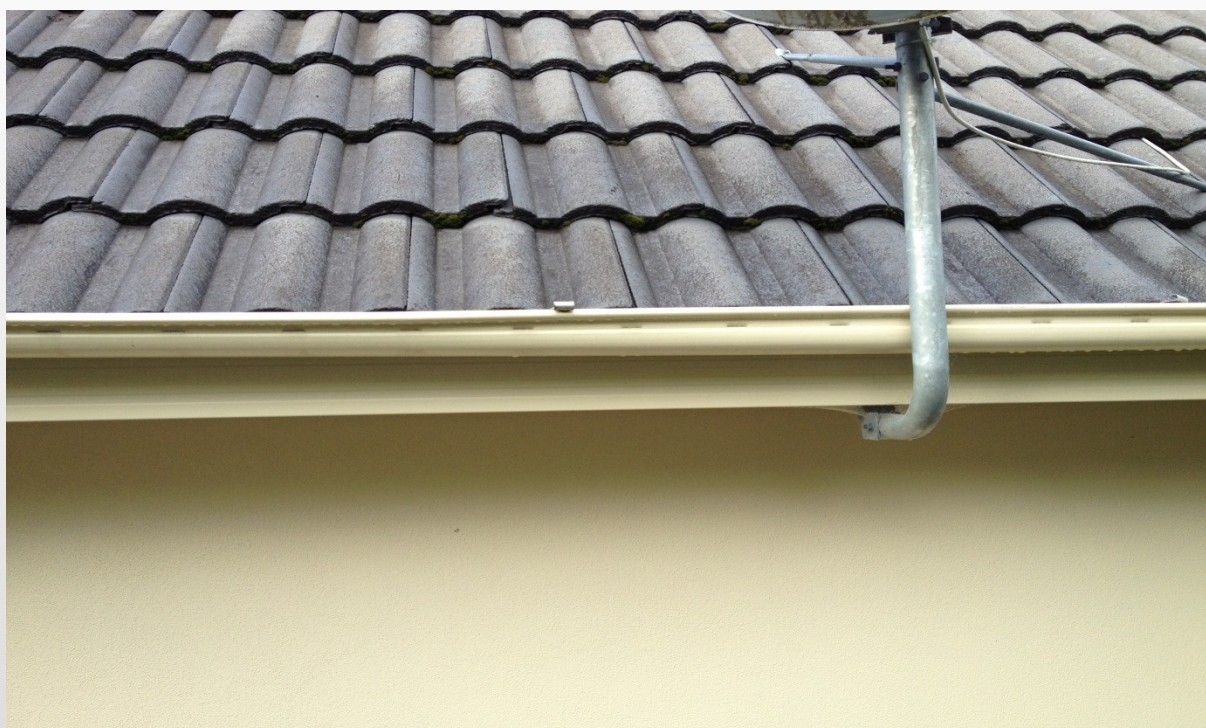
(3) The spouting has come of its clips where the Sky dish has been installed this will require repairing.

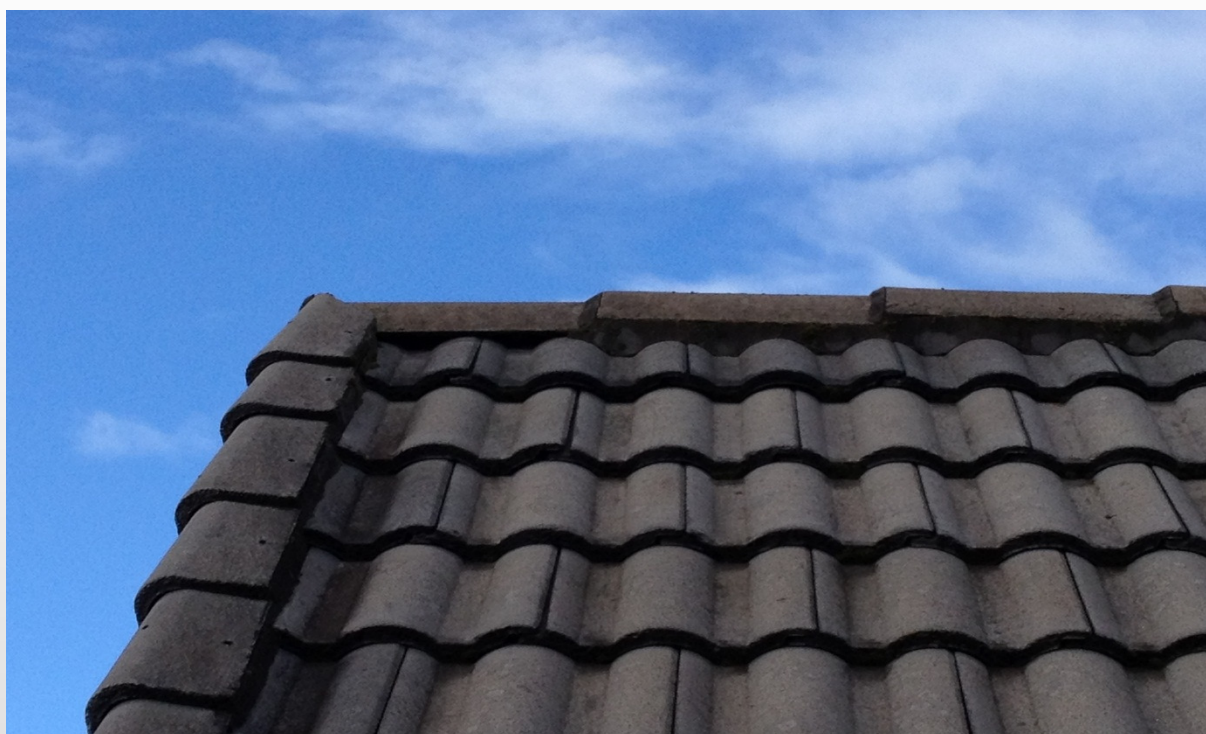
(4) There are some minor cracks in the ridge tile mortar and mortar is missing from 1 x ridge tile above the Scullery, These areas will require repairing.
